# Manhole Inspection Summary

Manhole # S55C\_\_019MH

**Location** Address: **rear 3531 esther place** Cross Street: **n conkling aver**

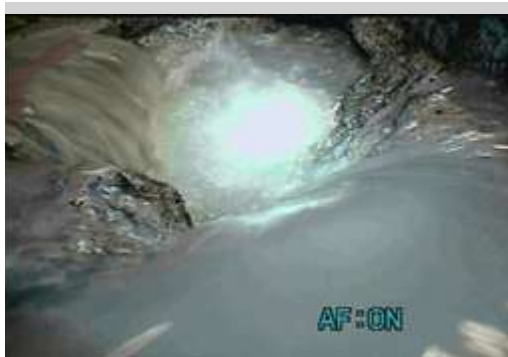
Defect 6

**Channel** Material: **Brick** ☐ Parged  
Channel Exposure: **Fully Open** Junc Dist: **0** nearest .5 ft. Azimuth: **0**  
Condition: ☐ Sound ☐ Cracked ☐ Root Intrusion ☐ Deteriorated ☐ Leaks ☒ **Debris**

channel debris

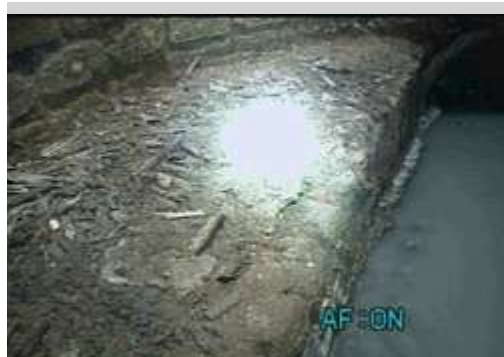
Defect 5

**Bench** ☒ Exists Material: **Brick** ☐ Parged  
Condition: ☐ Sound ☐ Cracked ☐ Root Intrusion ☐ Deteriorated ☐ Leaks ☒ **Debris**

bench debris

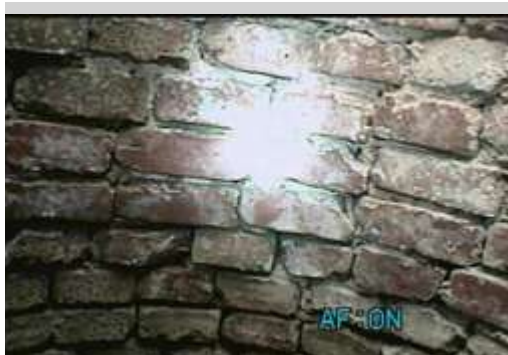
Defect 4

**Barrel** Material: **Brick** ☐ Parged  
Shape: **Circular** Diameter: **48** (in.) Length: **0** (in.)  
Condition: ☐ Sound ☐ Cracked ☐ Root Intrusion ☒ **Loose Brick** ☐ Deteriorated  
Infiltration: ☒ None ☐ Joint ☐ Cracks ☐ Mortar ☐ Roots ☐ Wall

loose brick & missing mortar in barrel

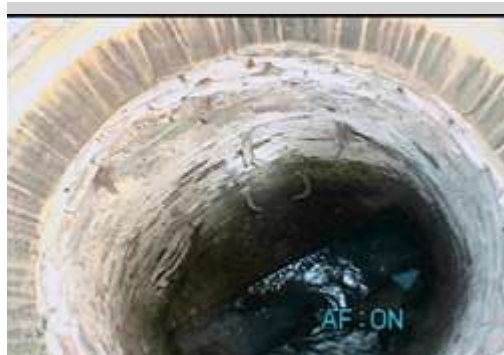
Defect 3

**Steps** Count: **4** Missing: **4** ☒ **Corroded**

missing & corroded steps

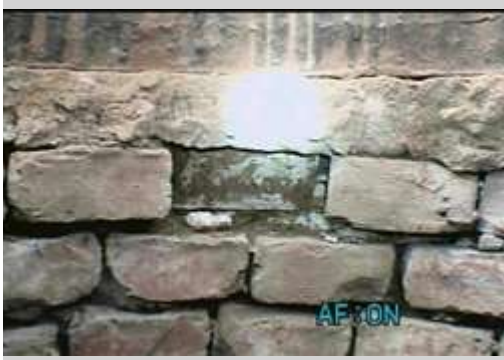
Defect 2

**Corbel** Material: **Brick** ☐ Parged Type: **Concentric/Eccentric**  
Condition: ☐ Sound ☒ **Cracked** ☐ Root Intrusion ☒ **Loose Brick** ☒ **Deteriorated**  
Infiltration: ☒ None ☐ Joint ☐ Cracks ☐ Mortar ☐ Roots ☐ Wall

cracked, loose bricks corbel

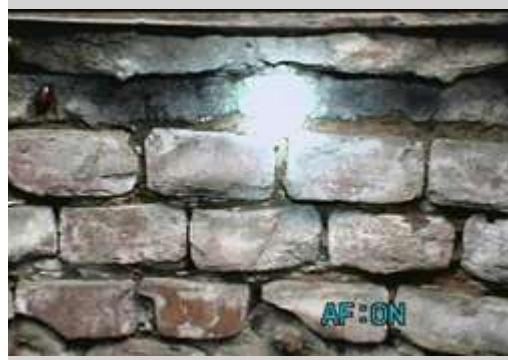
Defect 1

**Chimney / Frame Adjustment** ☒ Exists Material: **Concrete** ☐ Parged Height: **4** (in.)  
Condition: ☐ Sound ☒ **Cracked** ☐ Root Intrusion ☒ **Loose Brick** ☒ **Deteriorated**  
Infiltration: ☒ None ☐ Joint ☐ Cracks ☐ Mortar ☐ Roots ☐ Wall

chimney cracked, loose bricks frame adj

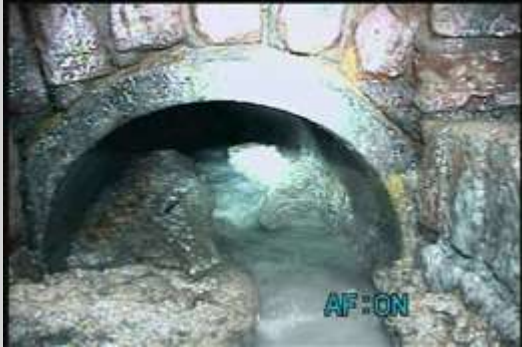
12 O'Clock Outflow

Deposits: ☐ None ☐ Mud ☒ **Sludge** ☐ Debris ☐ Grease

Silt Depth: 6 (in.) Deposits Extent: **Medium**

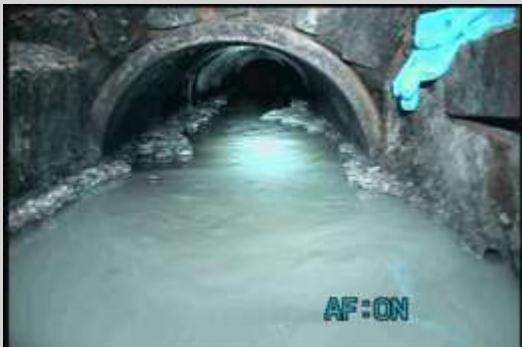
6 O'Clock Inflow

Deposits: ☐ None ☐ Mud ☒ **Sludge** ☐ Debris ☐ Grease

Silt Depth: 4 (in.) Deposits Extent: **Light**
